ZAPP TOOLING ALLOYS, INC.

Z-TUFF PM CASE STUDY EMBOSSING PUNCH

Embossing Punch

Dual Phase HSLA (980 Mpa)

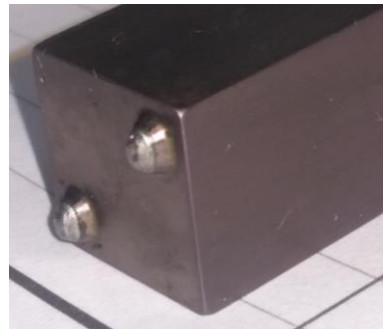
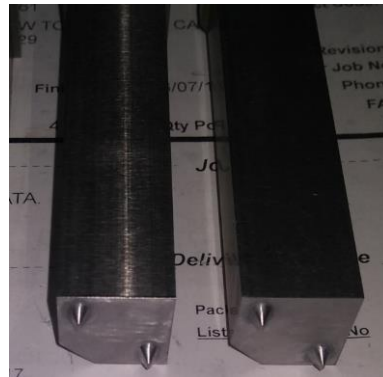
D2 punches failed prematurely because of excessive wear and chipping resulting in the need to produce 831 punches / year and excessive downtime on the press.

Z-Tuff PM with TiCN PVD Coating at Rc 60

Reduction from 831 punches per year to 330 Z-Tuff PM punches for an annual savings of \$251,000. Additional increases in production resulted from higher uptime on the press. Z-Tuff PM was the perfect substrate for the TiCN coating based upon excellent impact resistance at Rc 60 in combination with good compressive strength.
