TOOL TYPE

Fineblanking Punch

PROBLEM IDENTIFICATION

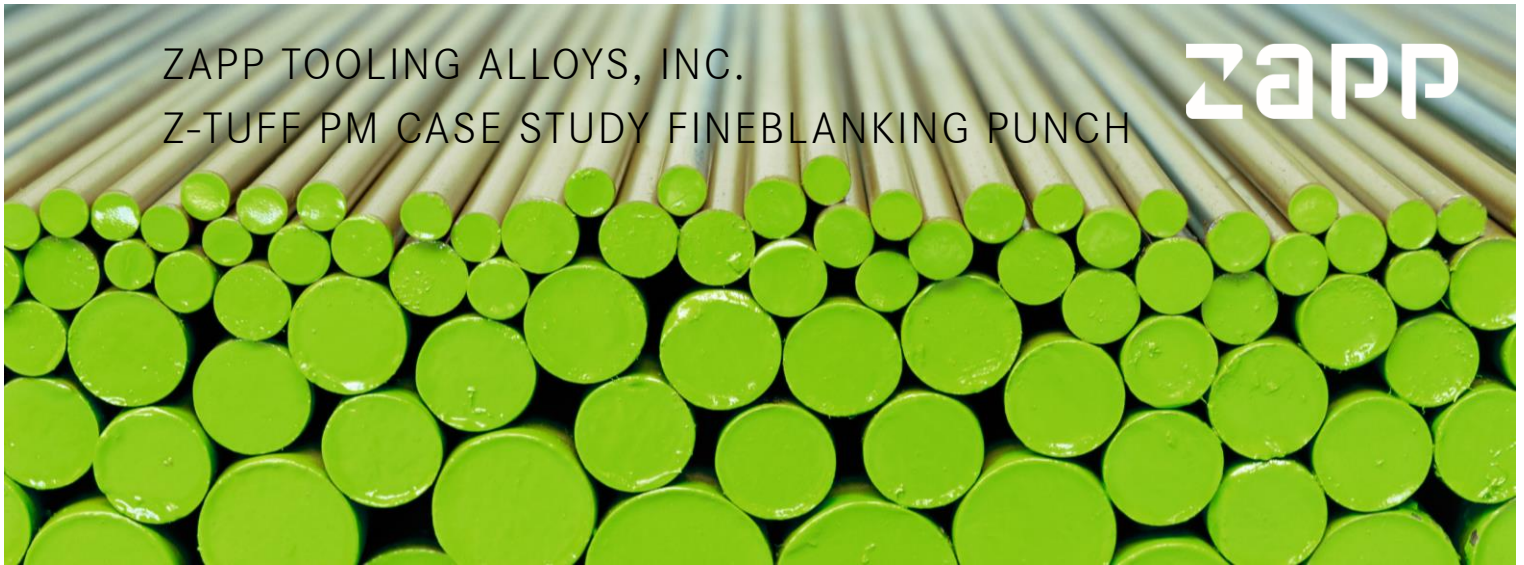
304SS at 12mm thickness

Complete punch failure. All previous grades (D2, M4 PM and CPM 3V) failure by catastrophic breakage.

Z-Tuff PM at Rc 60-62

Z-Tuff PM ran a total of 18,000 parts to complete the current requirements. Tool was put into storage awaiting next production requirement. Previously, the highest production from D2, 3V or M4 was 8,000 parts before the punch broke.
