ZAPP TOOLING ALLOYS, INC.

Z-TUFF PM CASE STUDY TRIM DIE

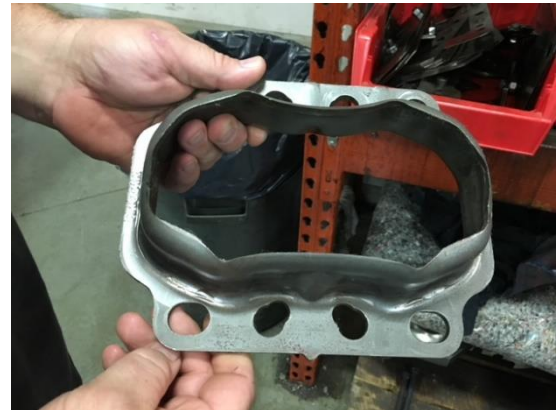
Trim Die

HSLA (620 Mpa)

All previous tooling materials broke in application. The maximum production with other materials was 2,000 - 3,000 parts. Breakage was experienced with A2, D2, S7, Caldie, DC53 and Vanadis 4E.

Z-Tuff PM at Rc 56-58.

Z-Tuff PM has provided 10X improvement running nearly 30,000 parts and even survived 2 double hits without breaking. Production improvements are impressive.
